FINAL
REMEDIAL ACTION SUMMARY REPORT

117TH AIR REFUELING WING
ALABAMA AIR NATIONAL GUARD
BIRMINGHAM INTERNATIONAL AIRPORT
BIRMINGHAM, ALABAMA

MARCH 1998

**PEER Consultants, P.C.
575 Oak Ridge Turnpike
Oak Ridge, Tennessee 37830**

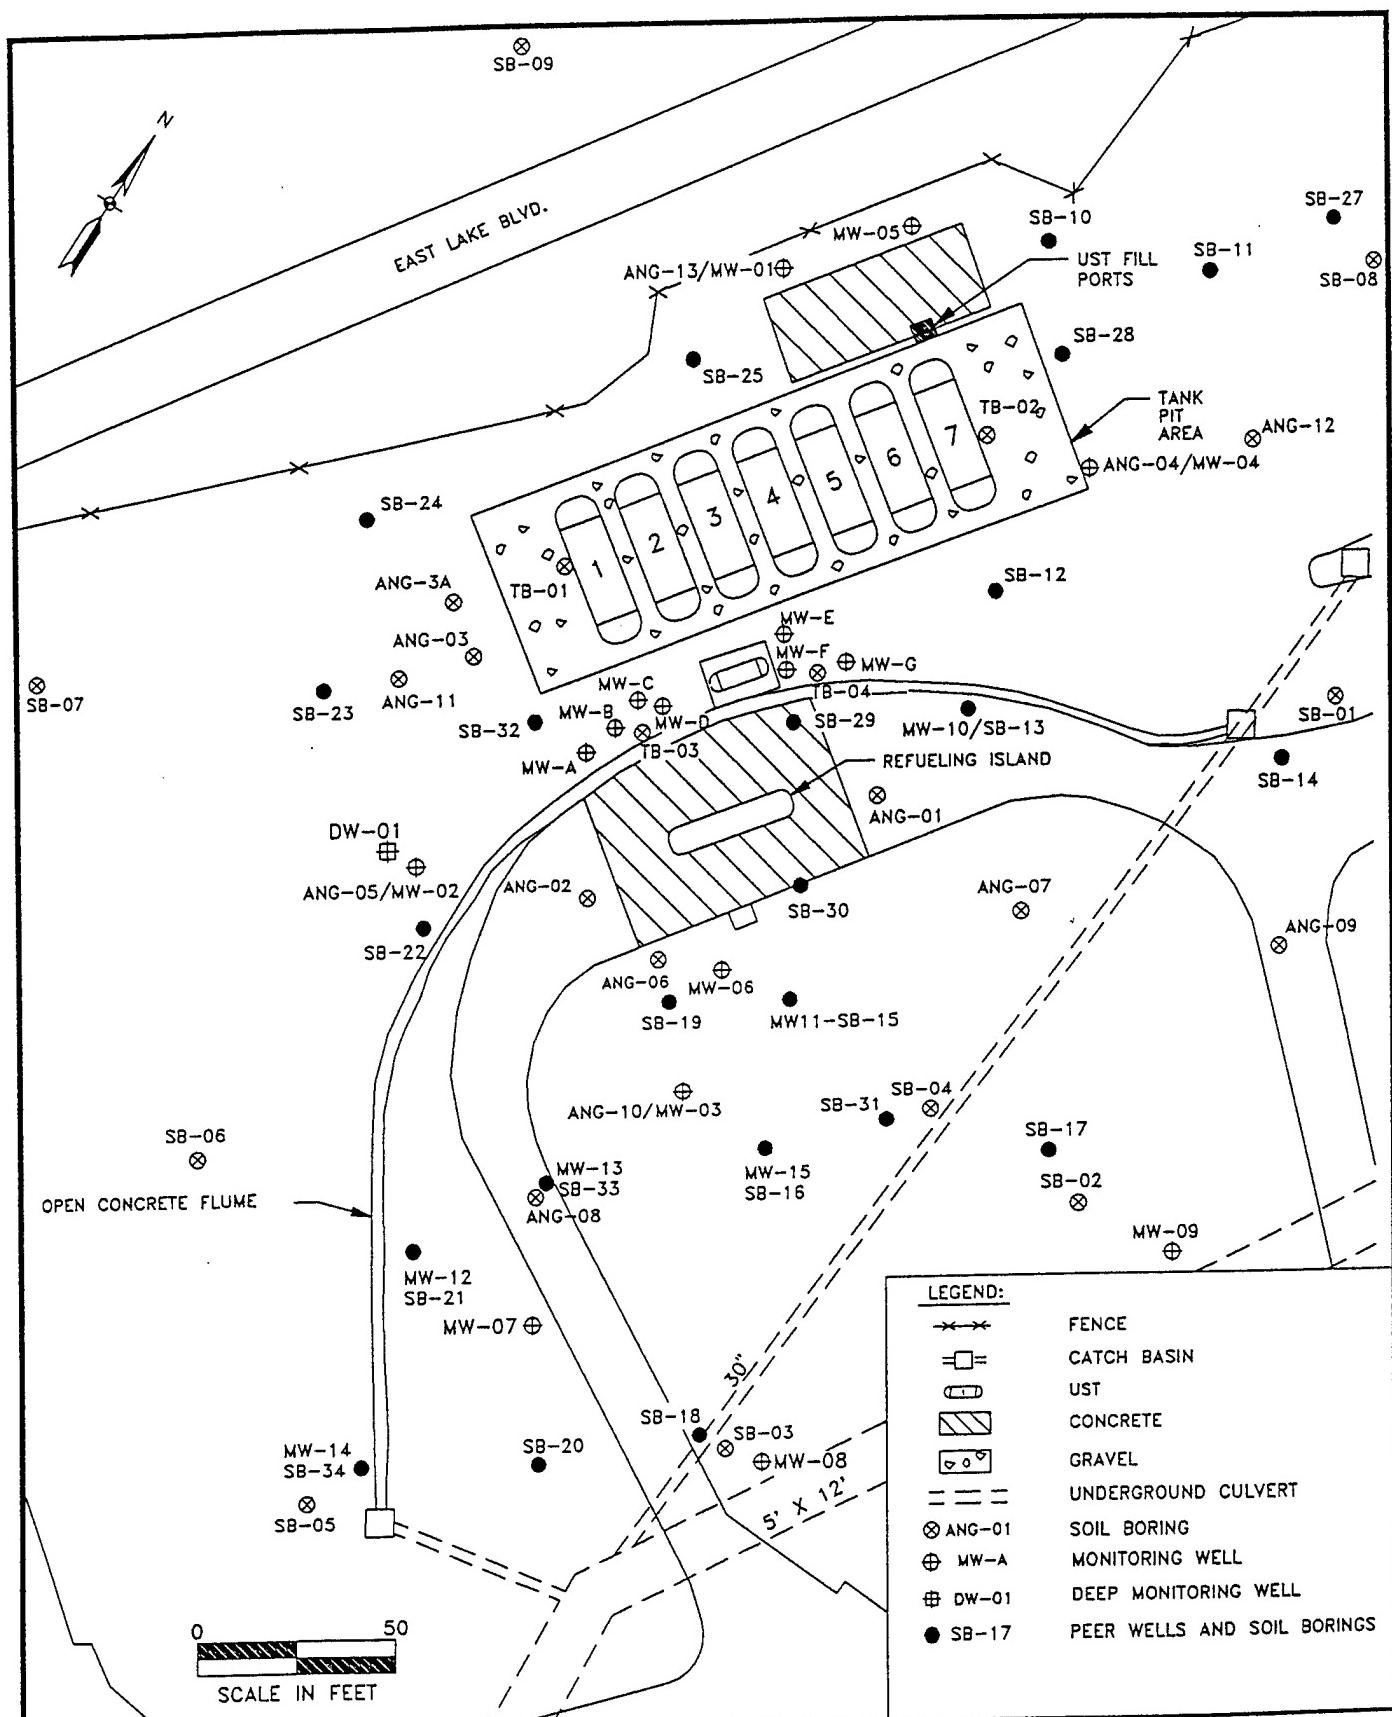
FIGURE
4.2

In addition to the soil contamination, free product was detected in four monitoring wells south of the UST pit (MW-07, MW-12, MW-13, and MW-15). The locations of the former monitoring wells are shown on Figure 4.2. According to the SA Report, groundwater at the site existed under confined and semiconfined conditions, and was influenced by infiltration of groundwater from the fill within the UST pit into the surrounding native soils along the UST distribution lines. Groundwater was present at the site at elevations ranging from 7 to 19 ft below ground surface (BGS), with the shallow elevations representing infiltration of groundwater from the UST pit and the deeper groundwater elevations representing water table conditions. Free product was found only in the shallow groundwater influenced by the UST pit with none being identified in the deeper (water table) groundwater (PEER 1992).

LOCATION OF PREVIOUS SOIL BORING/MONITORING WELLS
ALABAMA AIR NATIONAL GUARD
BIRMINGHAM, ALABAMA

During the remedial action and closure activities, all 23 monitoring wells were abandoned or removed from Site 11. The former locations of the abandoned monitoring wells are shown on Figure 4.2. Since that time, four new monitoring wells were installed at the site in order to fulfill ADEM closure requirements. These replacement wells are discussed in Section 5.6.

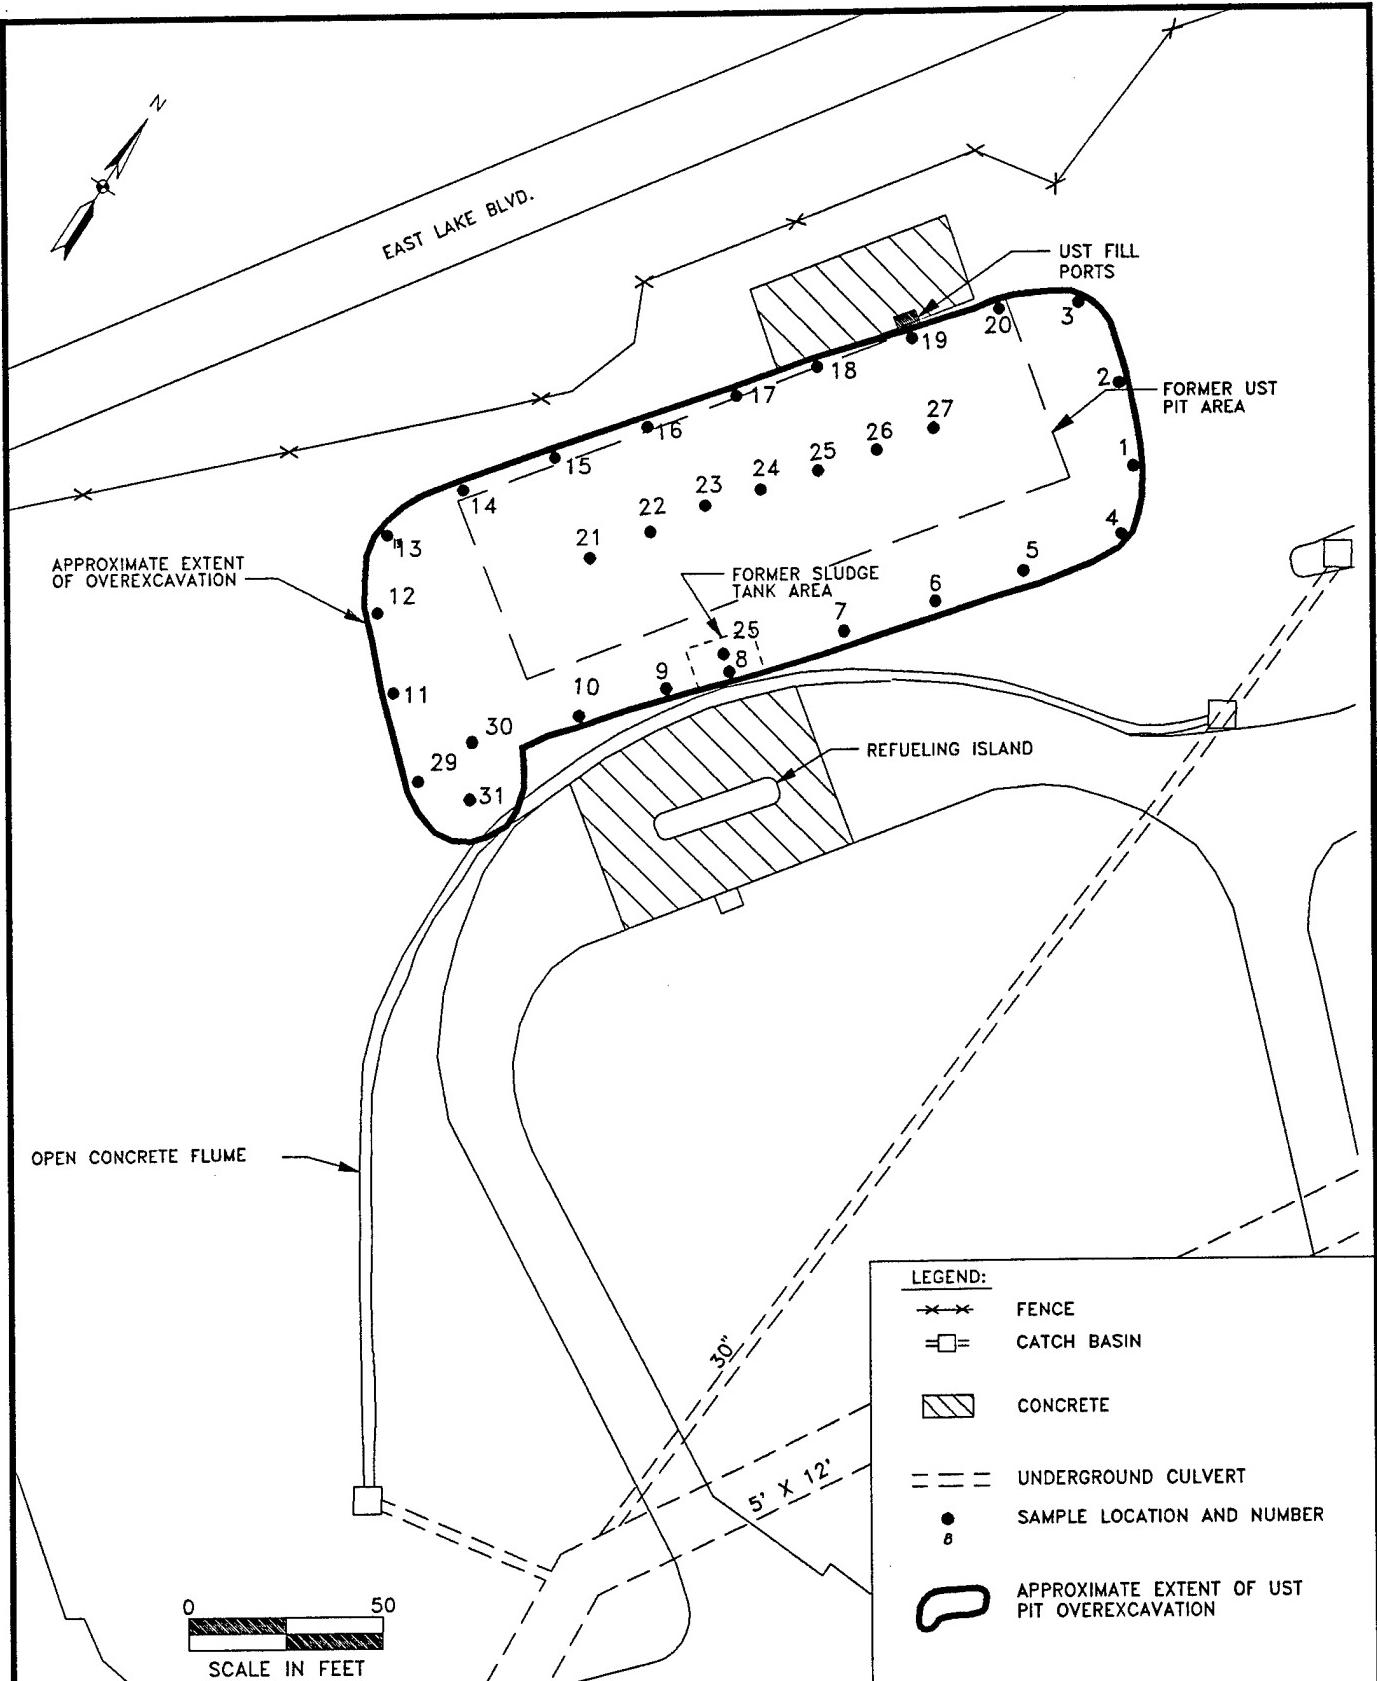
FIGURE
5.1

A total of 27 soil samples (EMC-1 through -27) were collected in the vicinity of the common tank pit on March 22, April 11, and April 26, 1994 by EMC. Samples were submitted to EMC Laboratory of Birmingham, Alabama, for analysis. Samples collected beneath the locations of the former tanks were obtained after the concrete pad was removed. The results indicated that no concentrations of TPH greater than the ADEM action limit of 100 mg/kg were found in the floor or side walls in the pit. Additionally, no concentrations of lead greater than the ADEM action limit of 100 mg/kg were found beneath the tanks. Analytical results of the side wall samples ranged from a low of not detected to a high of 24 mg/kg TPH, with an average detected concentration of 21 mg/kg TPH. Analytical results of pit floor samples ranged from a low of not detected to a high of 48 mg/kg TPH, with an average detected concentration of 28 mg/kg TPH. The lead analytical results of the pit floor samples ranged from a low of 16 to a high of 22 mg/kg, with an average concentration of 17 mg/kg lead. Several other metals also were detected in the samples. The detectable results for the other metals ranged from a high of 620 mg/kg (barium) to a low of 0.5 mg/kg (selenium). The remainder of the metals results are provided in the Corrective Action Report (EMC 1995).

UST CLOSURE SAMPLE LOCATIONS
ALABAMA AIR NATIONAL GUARD
BIRMINGHAM, ALABAMA

A total of 29 soil samples (PEER-1 through -7, and PEER-9 through -30) were collected in the vicinity of the common tank pit on April 26 and 27 and May 19, 1994, by PEER. The samples were submitted to Stillbrook Laboratories of Birmingham, Alabama, for analysis. Samples collected beneath the locations of the former tanks were obtained after the concrete pad present in the pit was removed. The results indicated that no concentrations of TPH greater than the ADEM action limit of 100 mg/kg were found in the floor or side walls in the pit, and no concentrations of lead greater than the ADEM action limit of 100 mg/kg were found beneath the tanks. Analytical results of the side wall samples ranged from a low of 6 to a high of 85 mg/kg TPH, with an average concentration of 18 mg/kg TPH. The TPH analytical results of pit floor samples ranged from a low of 11 to a high of 32 mg/kg TPH, with an average concentration of 19 mg/kg TPH. The lead analytical results of the pit floor samples ranged from 16 mg/kg to a high of 22 mg/kg, with an average concentration of 20 mg/kg.

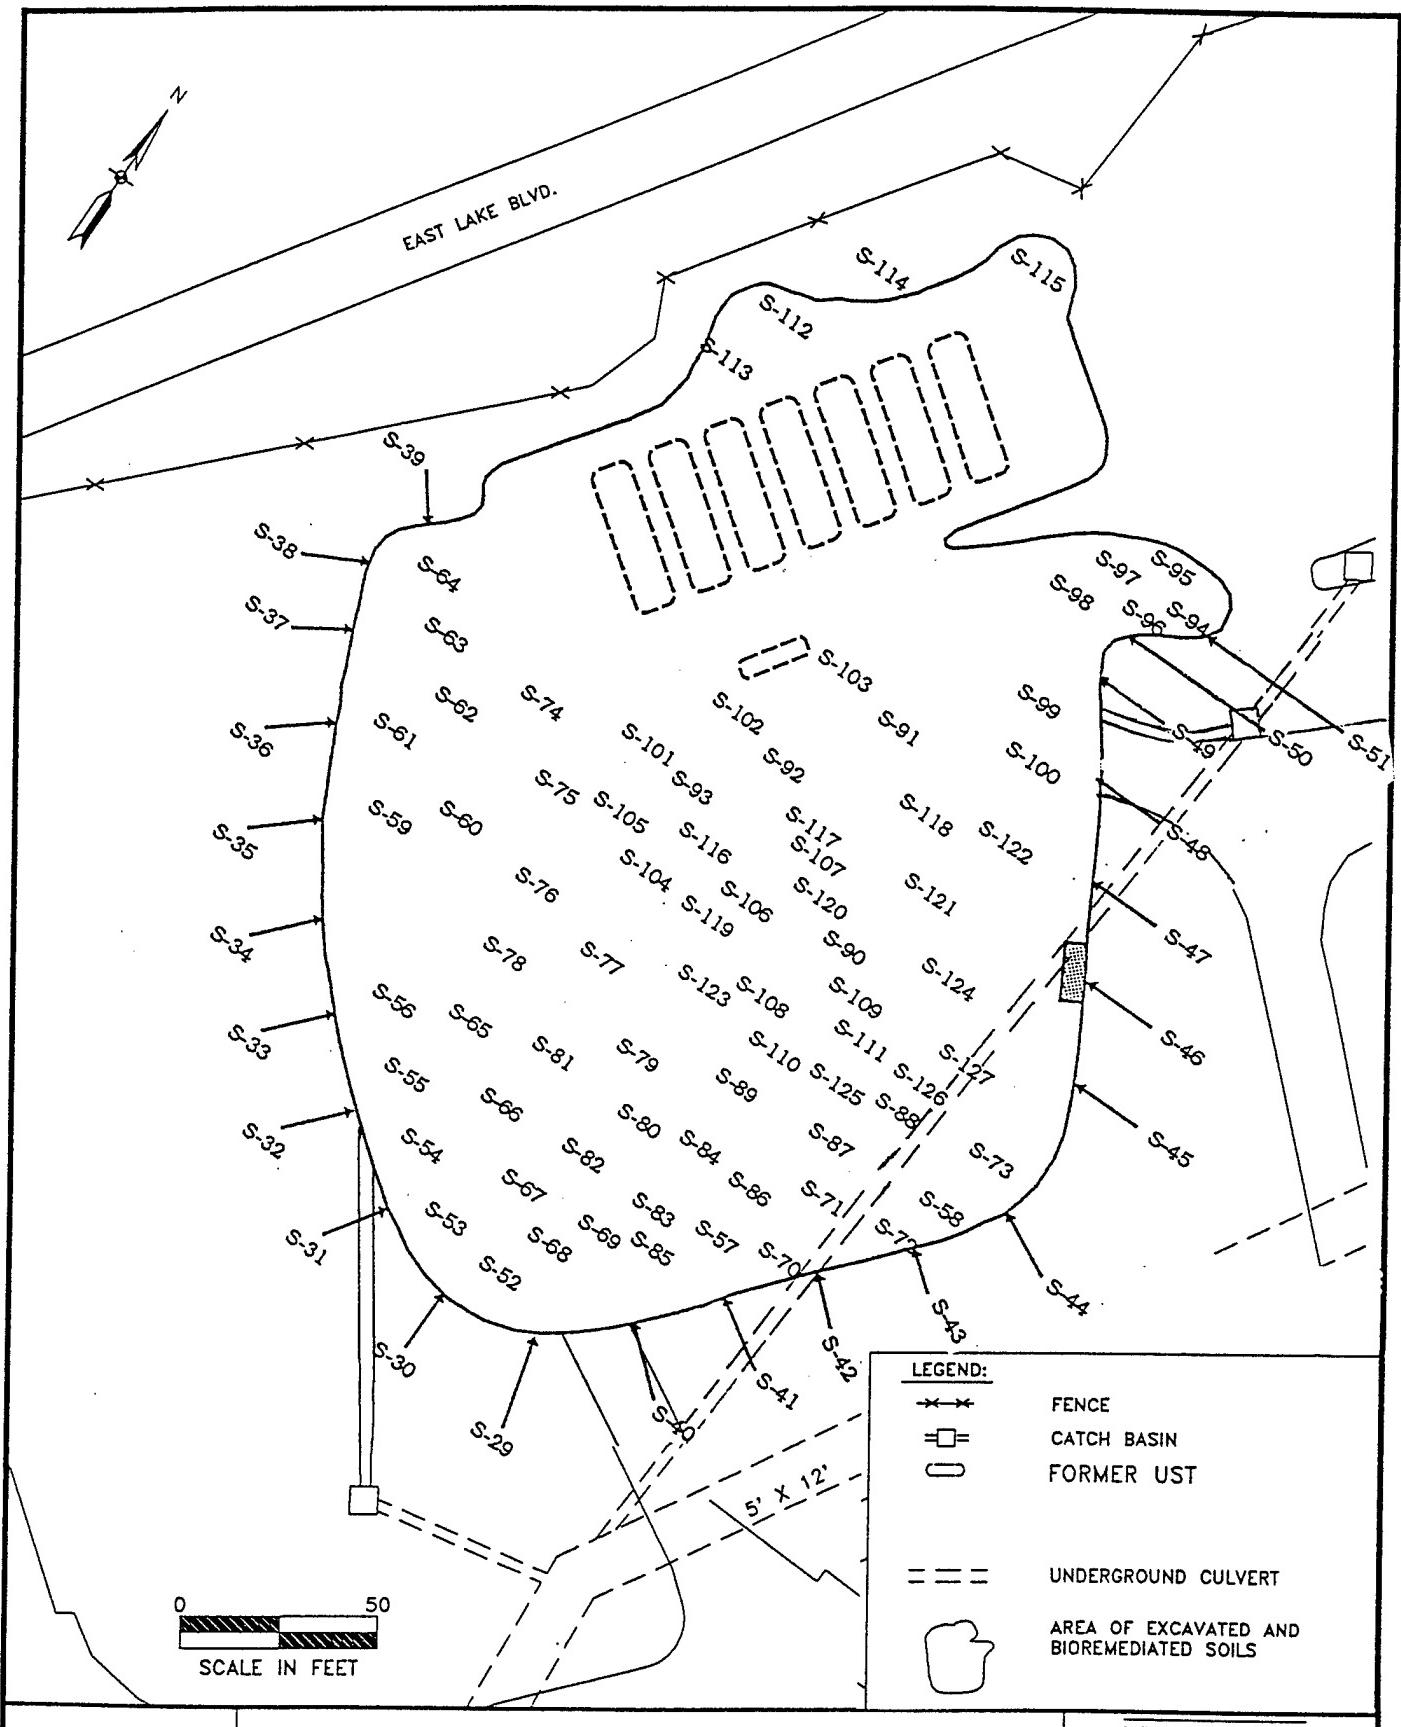
FIGURE
5.2

OVEREXCAVATED AREA FINAL SAMPLE LOCATIONS
ALABAMA AIR NATIONAL GUARD
BIRMINGHAM, ALABAMA

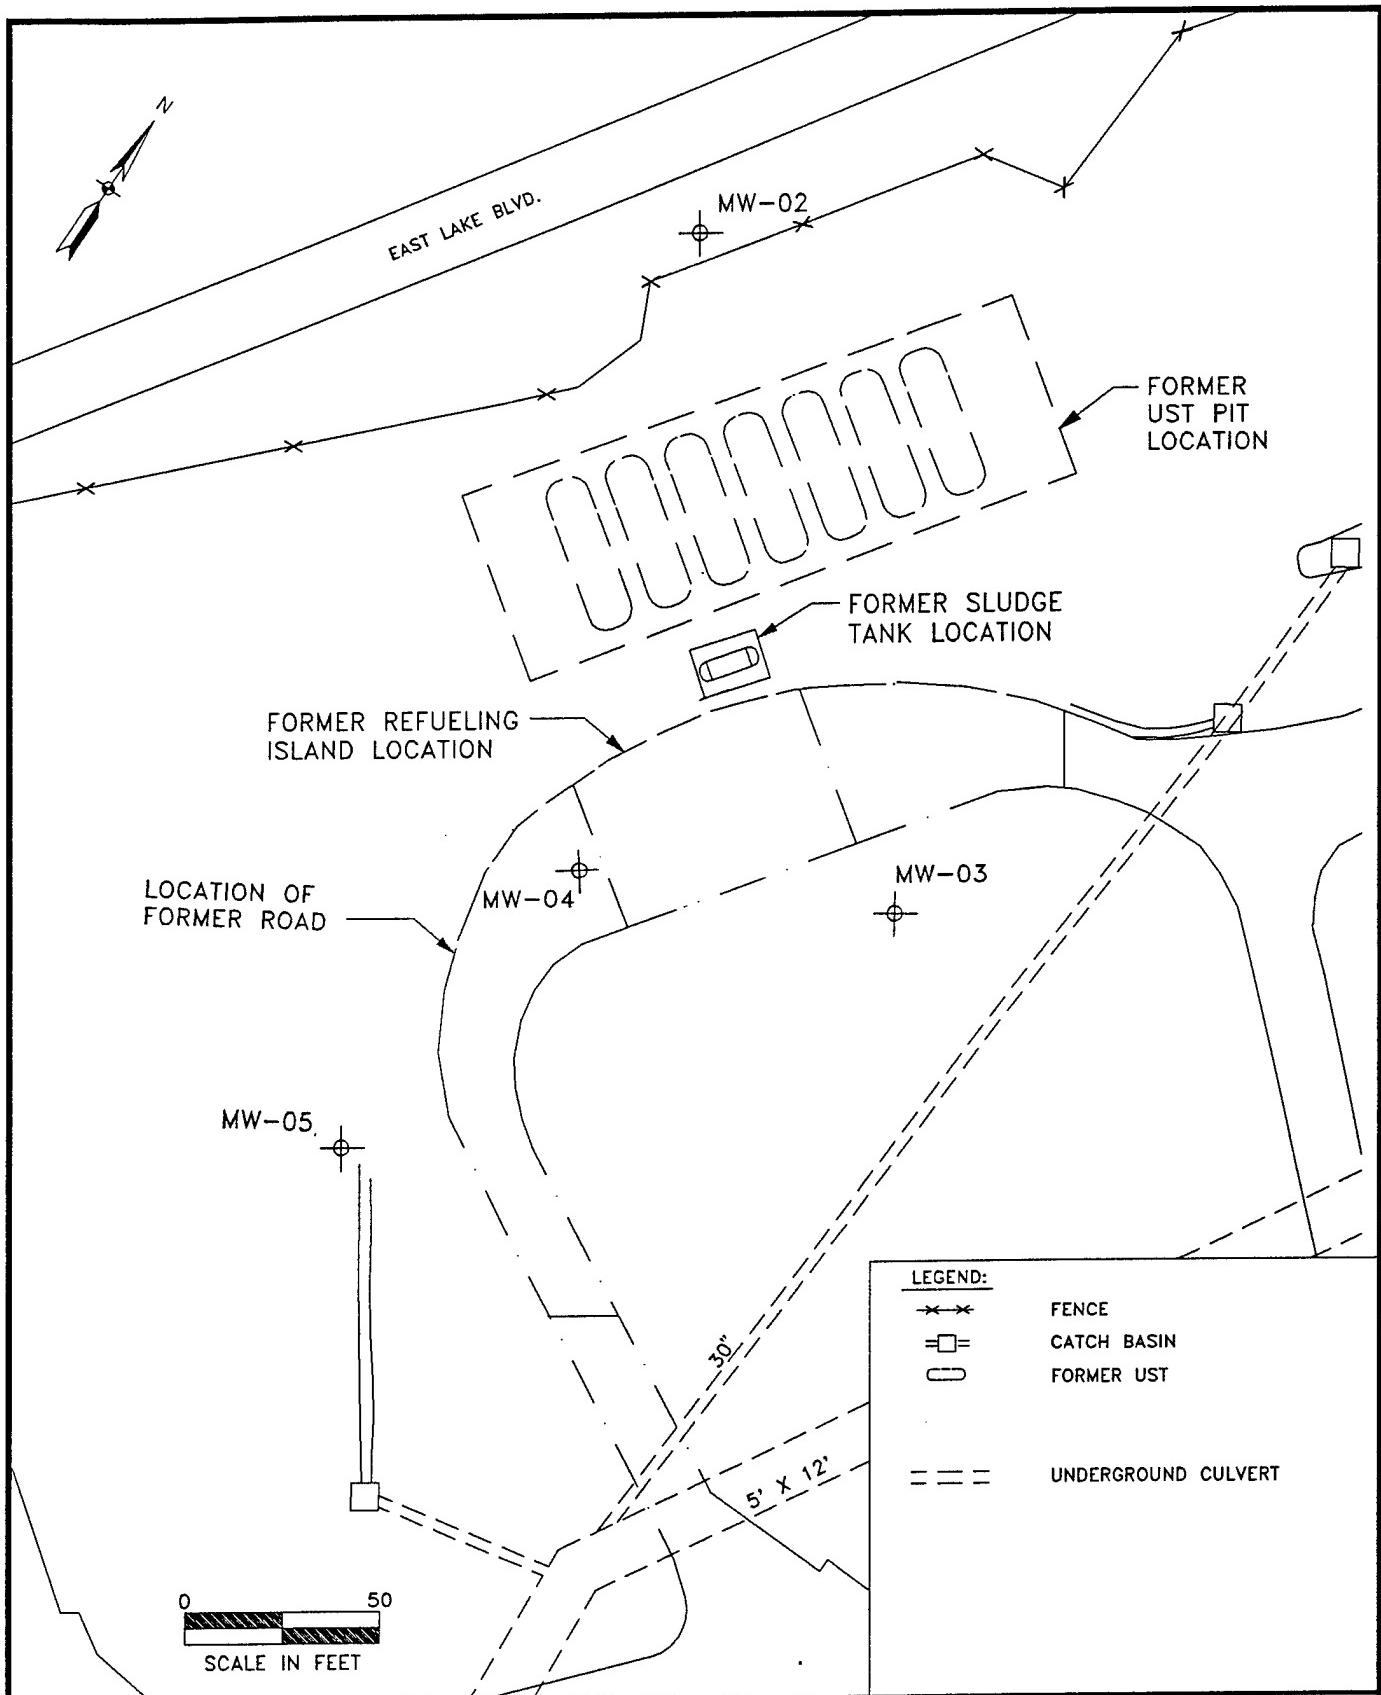
FIGURE
5.3

In September and October 1996, Birmingham Engineering & Construction Consultants installed four new groundwater monitoring wells in the vicinity of Site 11. The groundwater wells were installed in order to evaluate the effectiveness of the cleanup activities conducted at the site as previously described. Groundwater well MW-2 was installed topographically and hydraulically upgradient of the former UST pit as shown on Figure 5.3. The remaining three wells (MW-3, MW-4, and MW-5) were installed topographically and hydraulically downgradient of the former UST pit as shown on Figure 5.3. Groundwater wells MW-3, MW-4, and MW-5 were installed in borings of approximately 19 ft BGS, and water was encountered in each of the borings at around 17 to 18 ft BGS. Groundwater well MW-2 was installed in a boring of 38 ft BGS, and water was

NEW MONITORING WELL LOCATIONS
ALABAMA AIR NATIONAL GUARD
BIRMINGHAM, ALABAMA

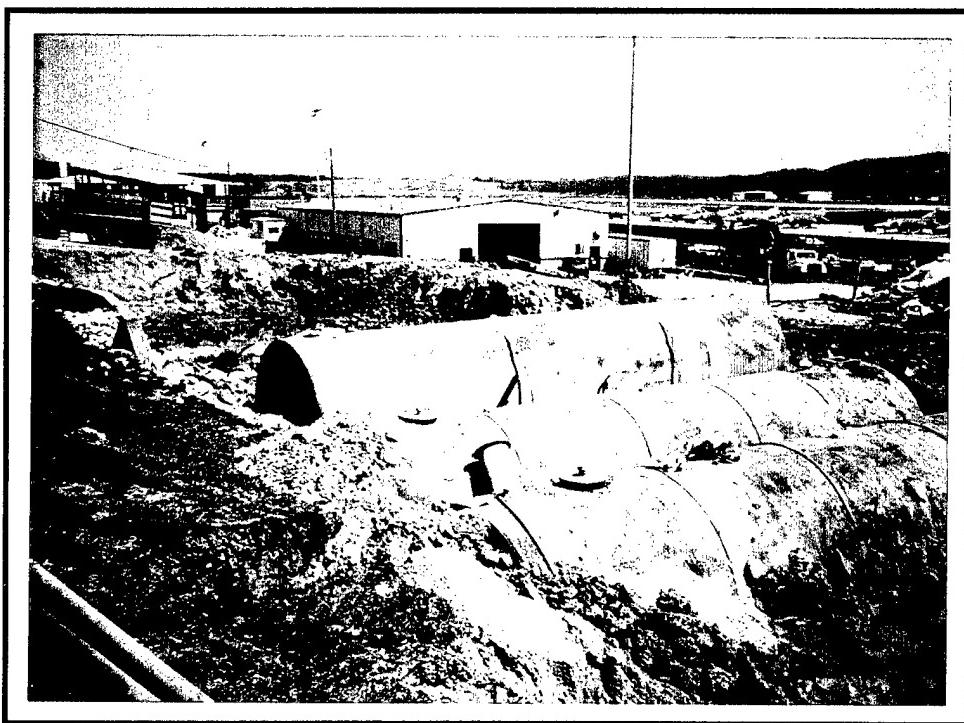
Photo No. 1: South-eastward view of UST pit with three USTs still in place.

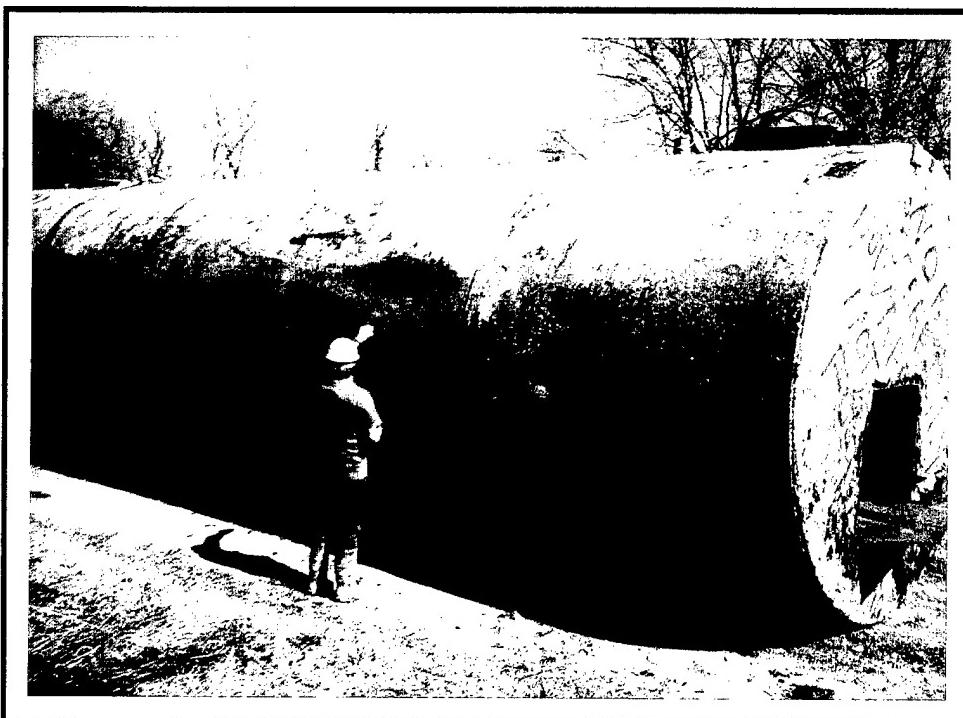
Photo No. 2: 25,000-gal fuel tank being inspected at scrap yard.

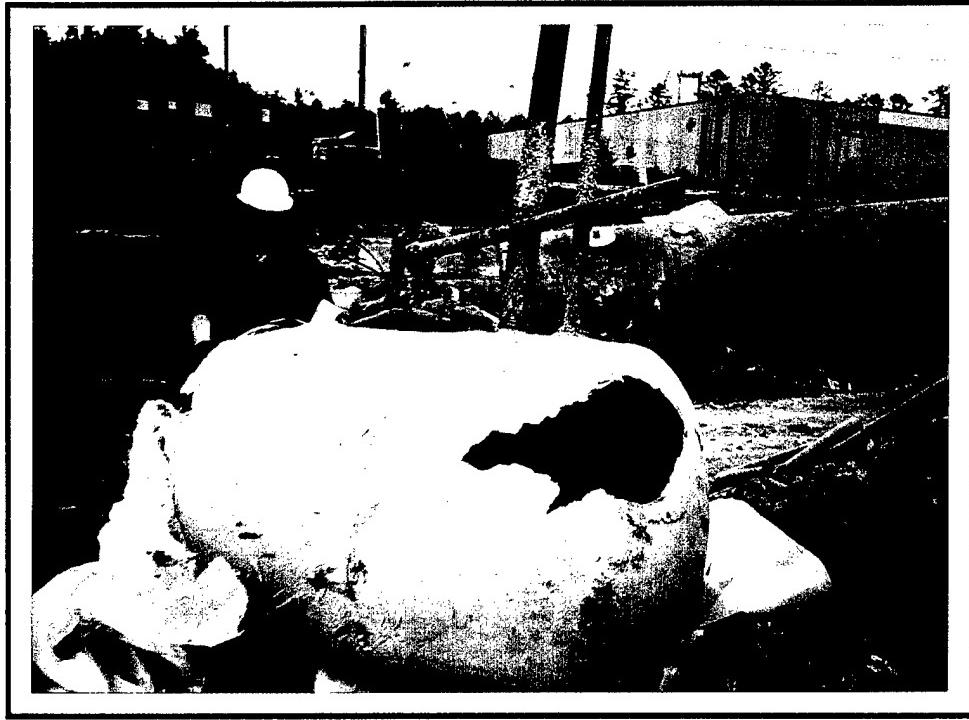
**Photo No. 3: 500-gal sludge tank after removal.
(Note - damage was caused during excavation)**

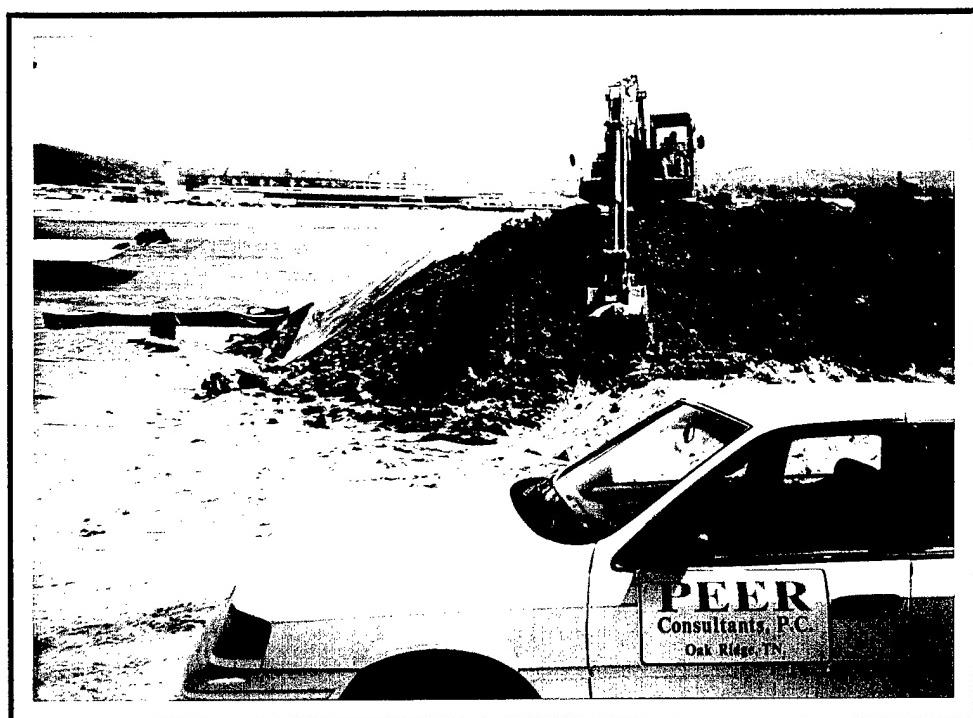
Photo No. 11: Soil stockpile in the vicinity of the site.
